FULL RESERVE STUDY

***SKYBROOK RIDGE TOWNHOMES
HUNTERSVILLE, NC***

Prepared for:
***SKYBROOK RIDGE TOWNHOMES HOMEOWNERS ASSOCIATION
HUNTERSVILLE, NC
&
KEY COMMUNITY MANAGEMENT***

SEPTEMBER 22, 2016

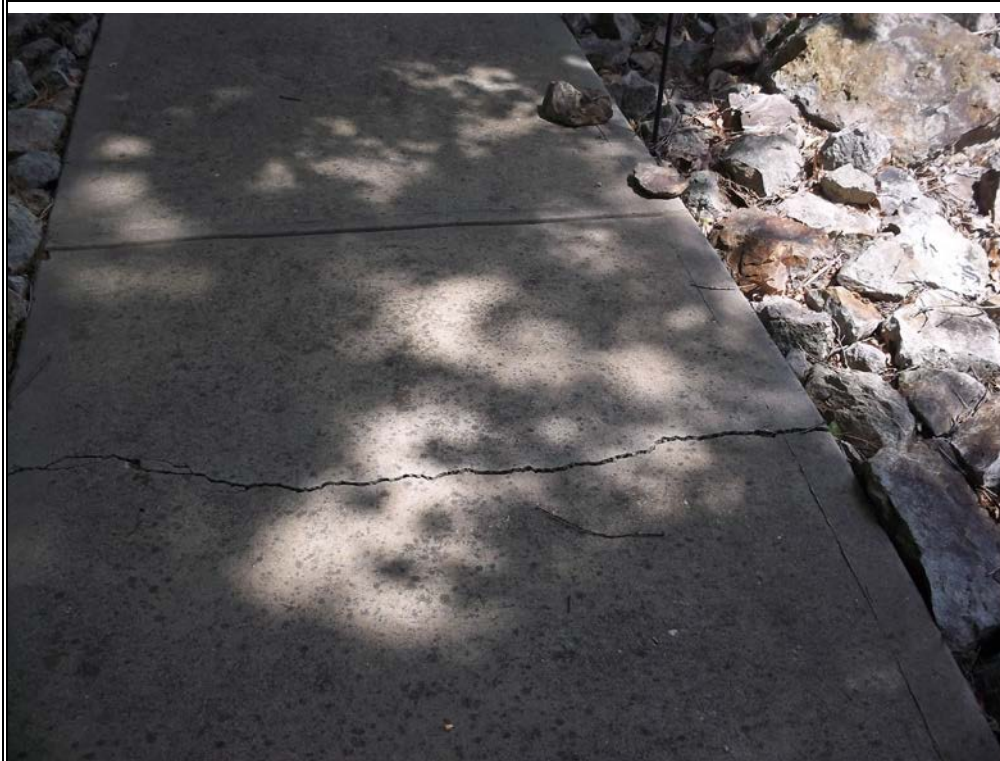
The association is responsible for maintaining the concrete flatwork consisting of the walkways and steps at the front of each building, driveways and rear patios. We noted areas of minor cracking developing in sections of the concrete flatwork. It is likely that due to differential settlement, cracking and deterioration in the concrete surfaces will continue and sections will eventually require significant repair. Repairs would include saw-cutting and removing damaged sections of concrete and forming, pouring and finishing new concrete replacement. The association reportedly plans to fund these repairs from an annual maintenance budget.

Minor cracking
developing in
concrete flatwork.

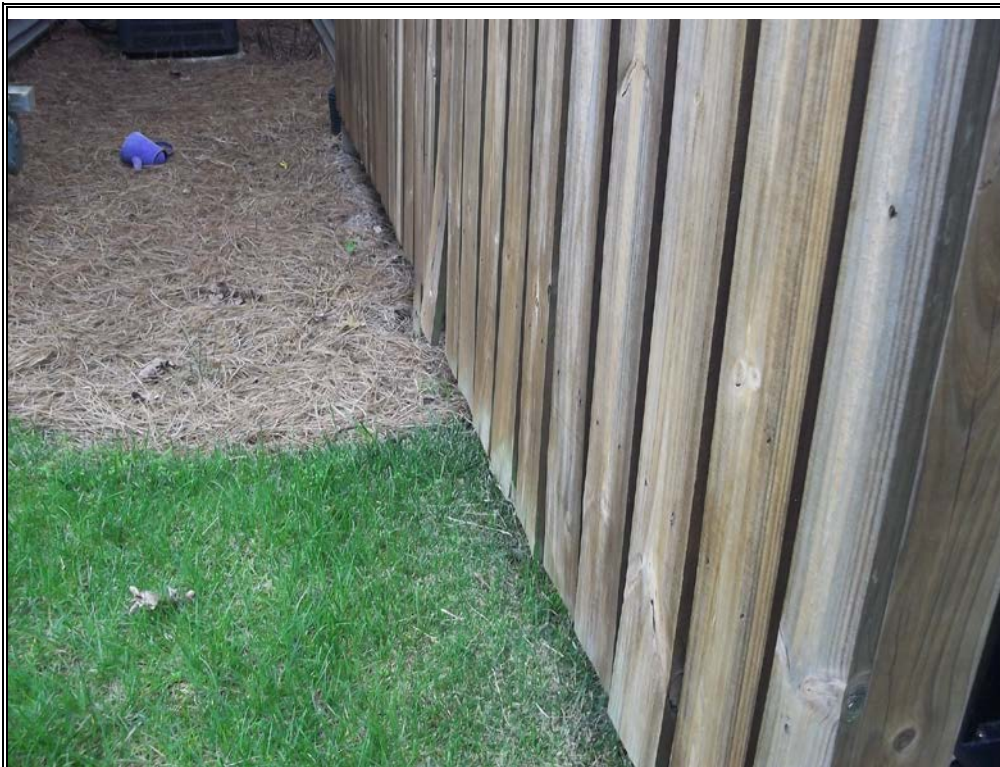
Photo Number
8

Wood rail fencing is installed along Linksland Drive near the entrance to the community. The fencing generally appeared to be in good condition and appears to be stained on a regular basis. Minor warping of individual members was observed. The association reportedly plans to fund repairing this section of fencing from an annual maintenance budget.

Description:
Minor warping
noted in individual
fence slats.

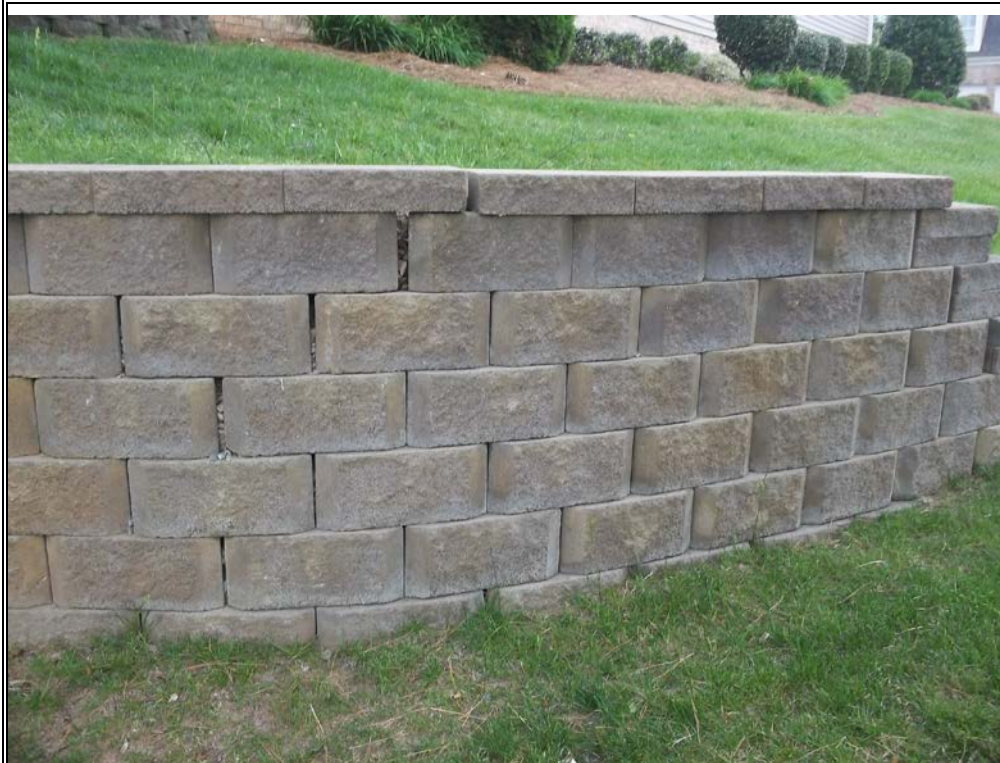
Photo Number
10

We noted concerns with the condition of the retaining wall to the right of 14814 Rocky Top Drive. Separation was noted between blocks in the wall and the wall appears to be slightly leaning/bulging outwards. We also noted moderate tree growth above this section of wall. This wall section should be closely monitored for additional movement. We have allocated funds to replace sections of the retaining walls on a 20 year cycle beginning in 2022. Replacement walls may include similar segmental concrete block retaining walls with geo-grid reinforcement or pre-cast concrete block gravity wall systems. Note that replacement retaining walls should be designed by a Professional Engineer and should include the installation of drainage systems behind the walls to relieve hydrostatic pressure. Note that we strongly recommend periodic inspections of the retaining walls for additional movement and deterioration.

Description:
Section of
retaining wall with
separation noted
between blocks.

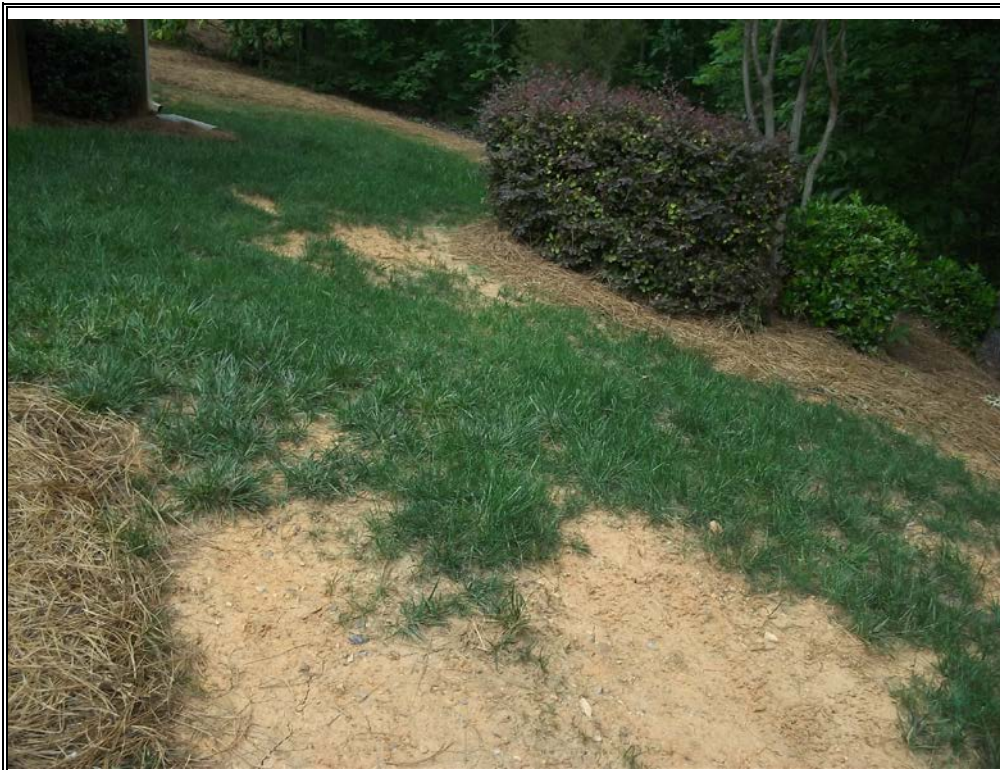
Photo Number
12

appeared to be in good condition. However, there are areas of significant slope around the community and many sections of retaining walls. We noted minor soil erosion developing in areas of the community. Maintaining adequate soil stabilizing ground cover will help reduce erosion and drainage concerns.

Description:
Area of minor soil
erosion noted.

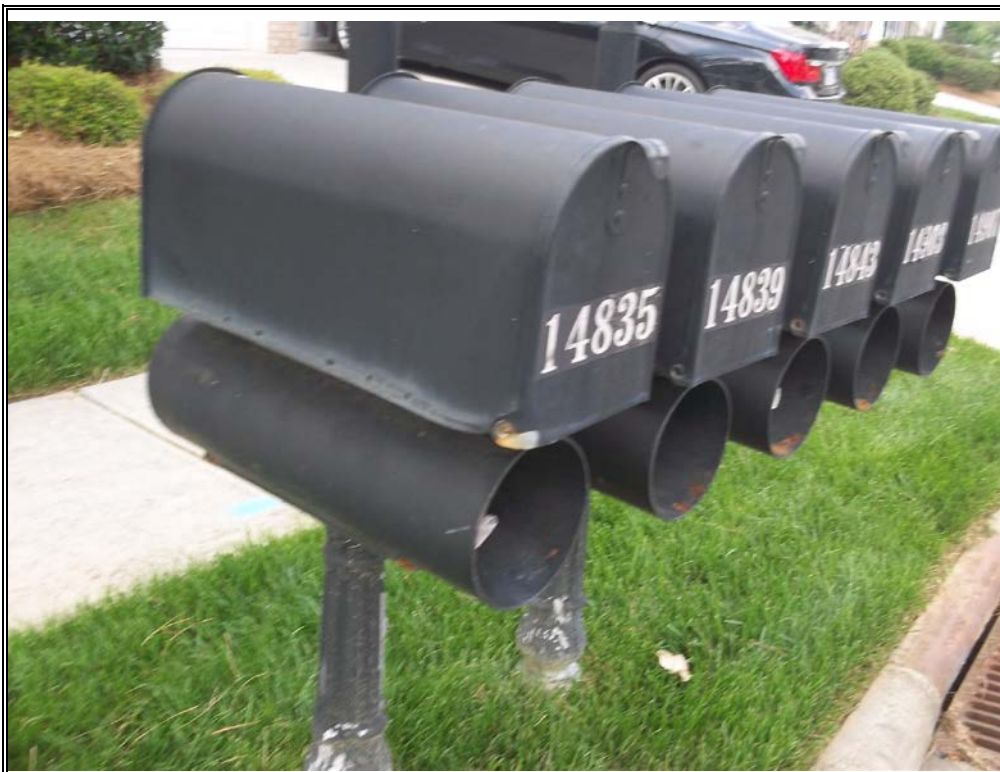
Photo Number
14

Mailboxes are installed on posts in front of the buildings. The metal mailboxes generally appeared to be in good to fair condition, with areas of flaking paint observed. The association reportedly plans to fund mailbox repairs and replacement from an annual maintenance budget.

Description:
Mailboxes.

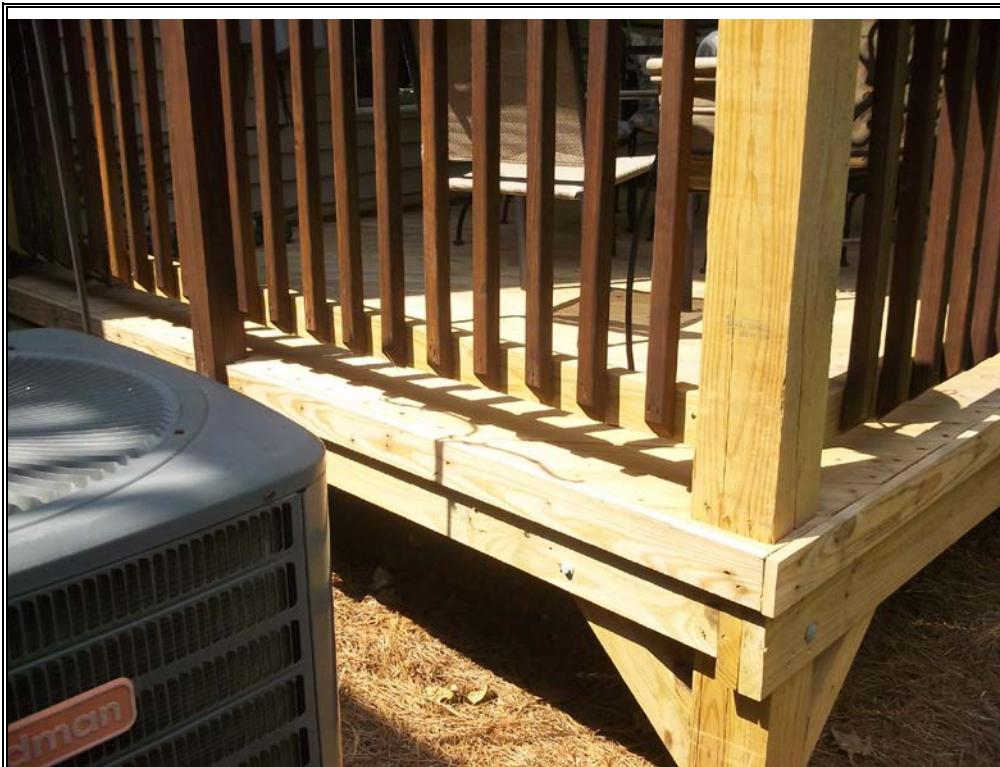
Photo Number
16

Many of the townhomes include rear decks. The decks are of wood construction and of various sizes. Some units include 2 story decks. The decks generally appeared to be in good condition. The association reportedly follows a routine maintenance and inspection schedule with decks periodically repaired and stained/sealed. This routine maintenance has been funded from an annual maintenance budget. Assuming regular maintenance and staining/sealing are completed in the interim, we estimate the decks to have a remaining useful life of approximately 15 years prior to major repairs. Major repairs would include replacing all the decking and railings and repairing the wood framed structure as needed. We have allocated funds for major repairs to the decks in 2032.

Description:
Recently
completed repairs
to decks.

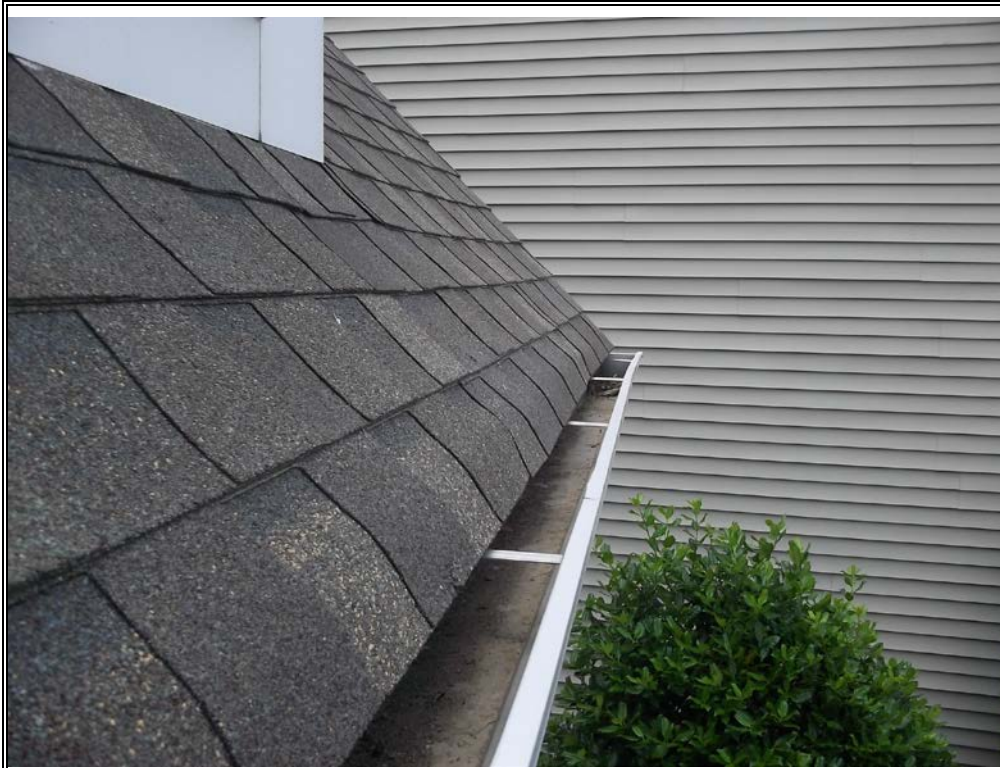
Photo Number
19

Gutters and downspouts are in generally good condition. We strongly recommend periodic cleaning and repairs/adjustments of gutters and downspouts to allow adequate flow of stormwater. We have allocated funds to replace the gutters and downspouts throughout the community in 2029-2031 in conjunction with the roof replacement noted above. The gutters appeared to be standard 4" K-style gutters with 2" x 3" downspouts. Based on some basic surface area calculations, the association may consider replacing gutters on the rear faces of the buildings with larger 5" or 6" K-style gutters with larger downspouts.

Close up view of shingles and gutters.

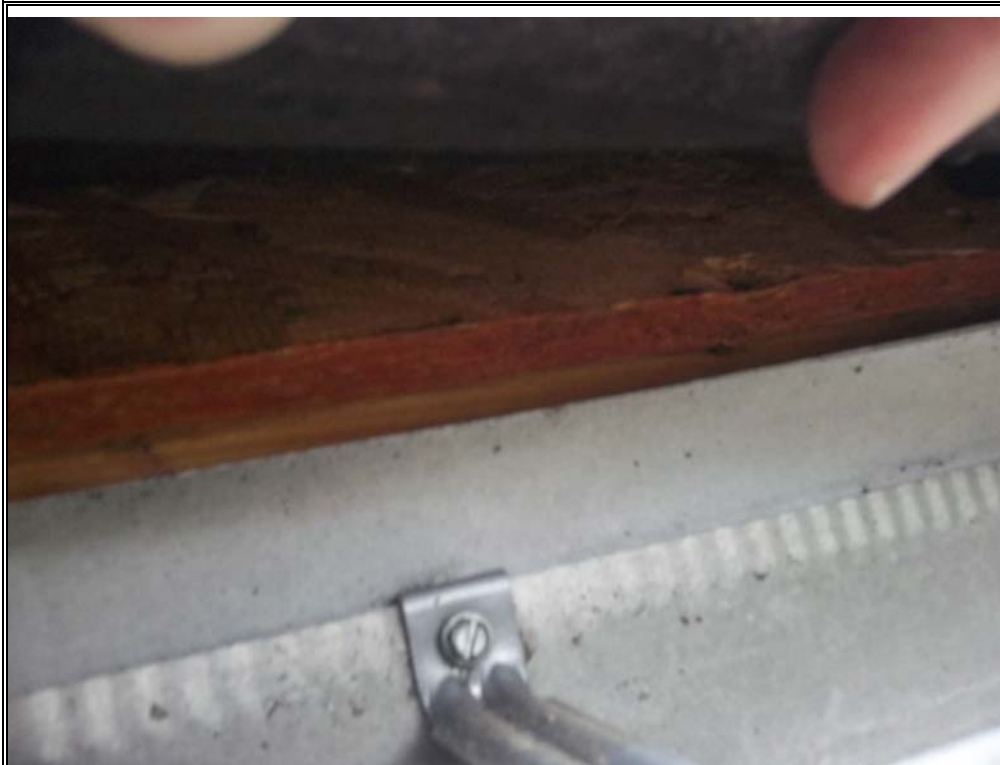
The predominant pitched roof surfaces over the buildings are covered in asphaltic fiberglass shingles. Roof surfacing is applied over wood roof sheathing, and generally appears to be in good condition. The shingles generally appeared to be in good condition with minor texture loss noted as typical with age. However, it does not appear that felt paper underlayment is installed under the shingles in all areas. The roof systems do include drip edge flashing and nailing patterns in inspected shingles appeared to be adequate.

View of drip edge flashing, missing felt paper under shingles, roof sheathing.

This type of roofing has an expected useful life of approximately 20 years. We strongly recommend that any re-roofing project closely follow procedures outlined by the National Roofing Contractors Association's *Roofing and Waterproofing Manual*. A re-roofing sequence should include removal of the existing roofing material, replacement of any inadequate roof sheathing, replacement of any damaged flashing, and replacement of

drip edge components. We have allocated funds to replace the roofs on all of the buildings in three phases beginning in 2029 and continuing each year through 2031.

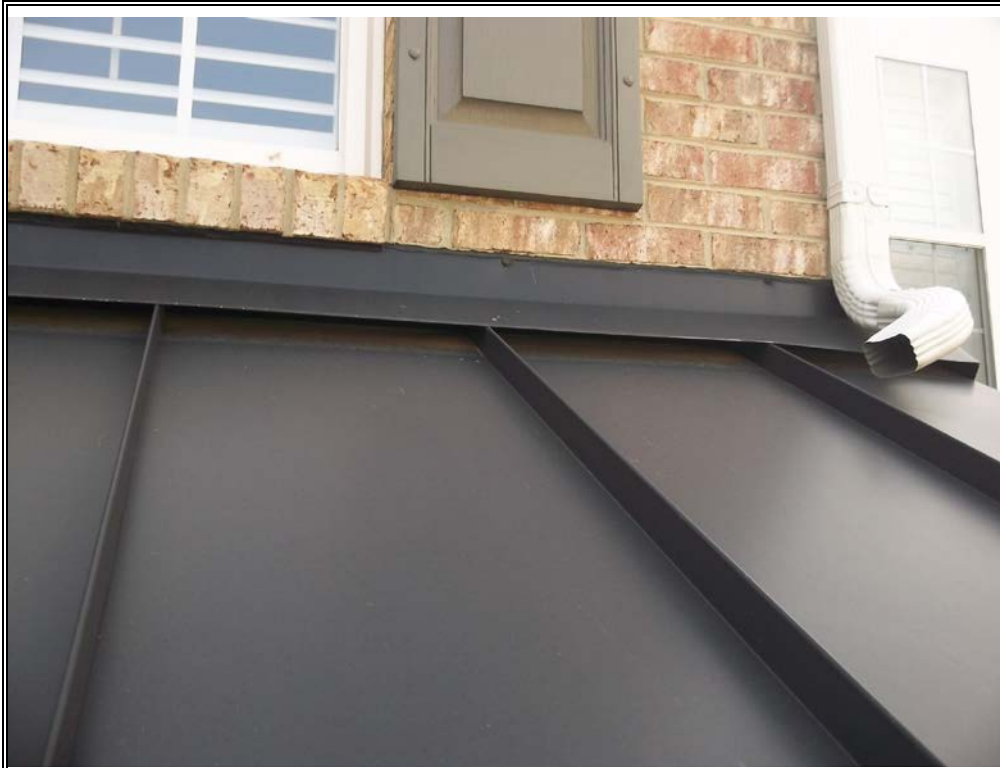
Photo Number
21

Limited sections of roofing is clad in standing seam metal roofing which appeared to be in good condition. We do not anticipate replacement of the standing seam metal roofing will be required over the term. Minor repairs and spot painting may be required, and we have assumed this would be funded from an annual maintenance budget.

Close up view of standing seam metal roofing in good condition.
